ADVANCED COMPOSITE ELEVATOR FOR BOEING 727 AIRCRAFT VOLUME 2—FINAL REPORT

Boeing Commercial Airplane Company
P.O. Box 3707, Seattle, WA 98124

CONTRACT NAS1-14952
NOVEMBER 1980

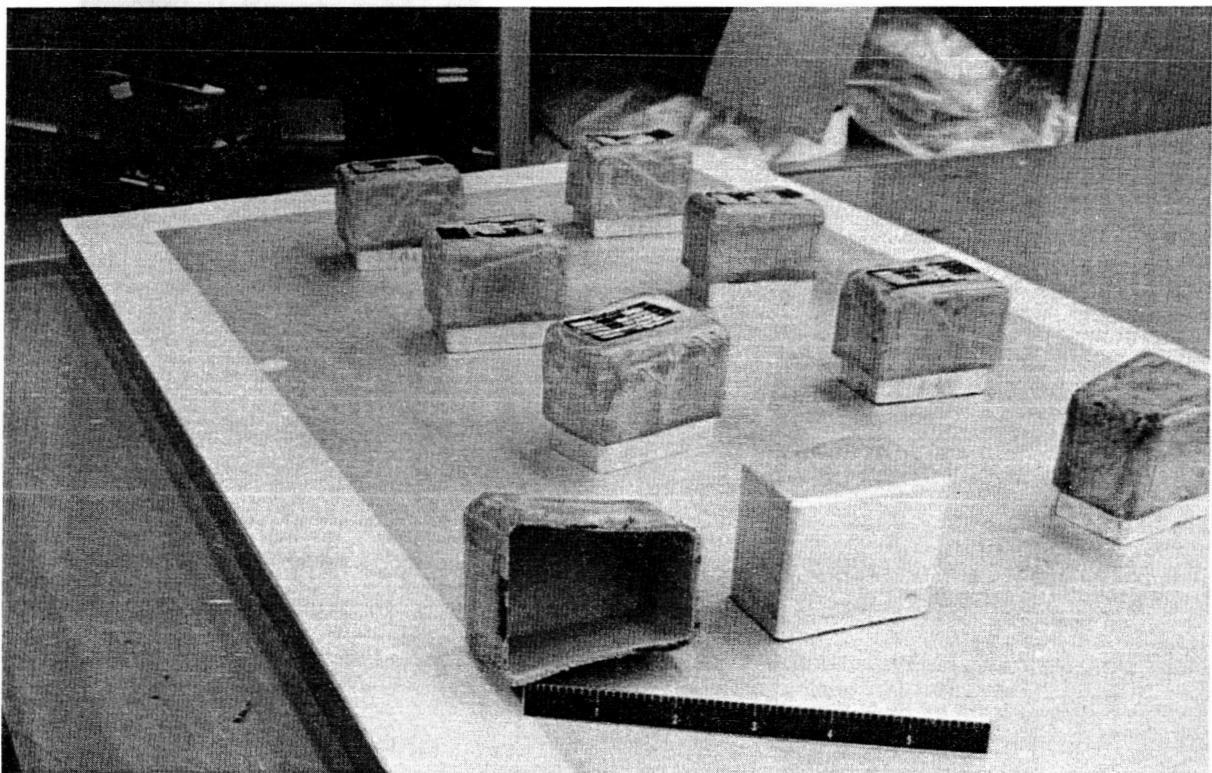
Figure 225. Rear-Spar Header Layup Mandrels

Layup Mandrel—A tool that uses silicone rubber pressure caps and makes eights parts (fig. 225).

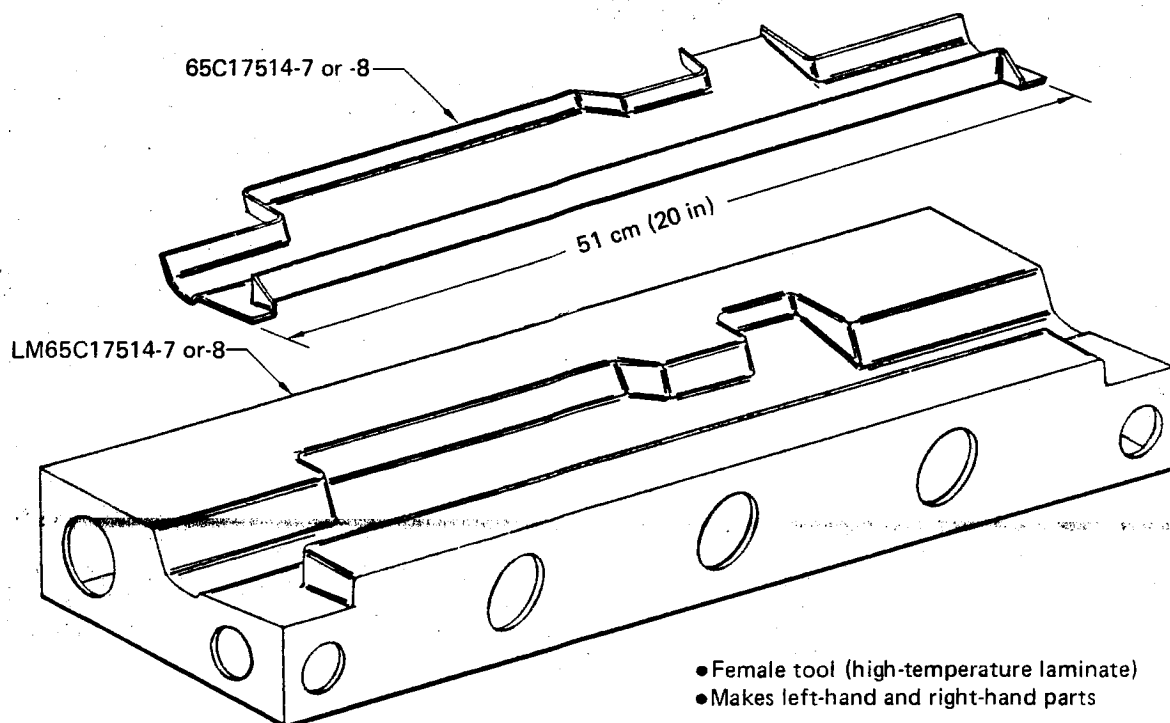
Figure 226. Actuator Fairing and Layup Mandrel

Layup Mandrel—This tool is shown in Figure 226.

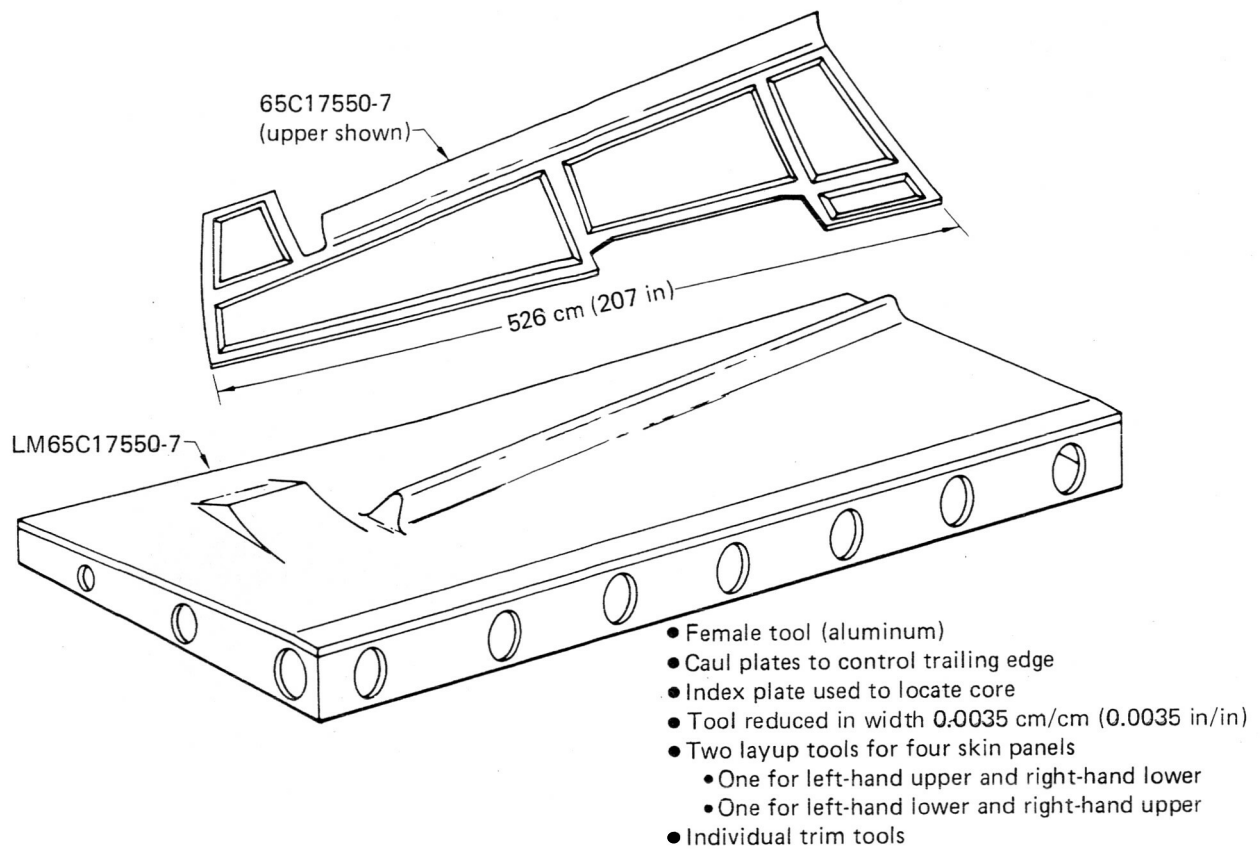
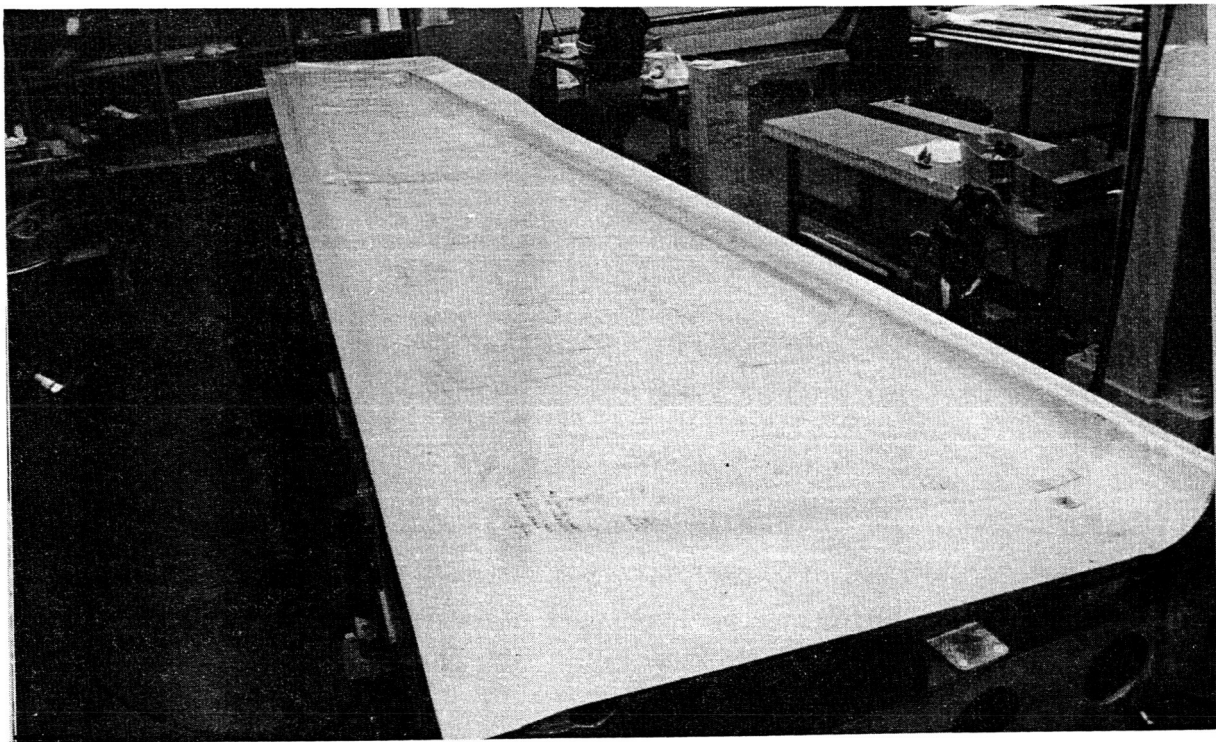
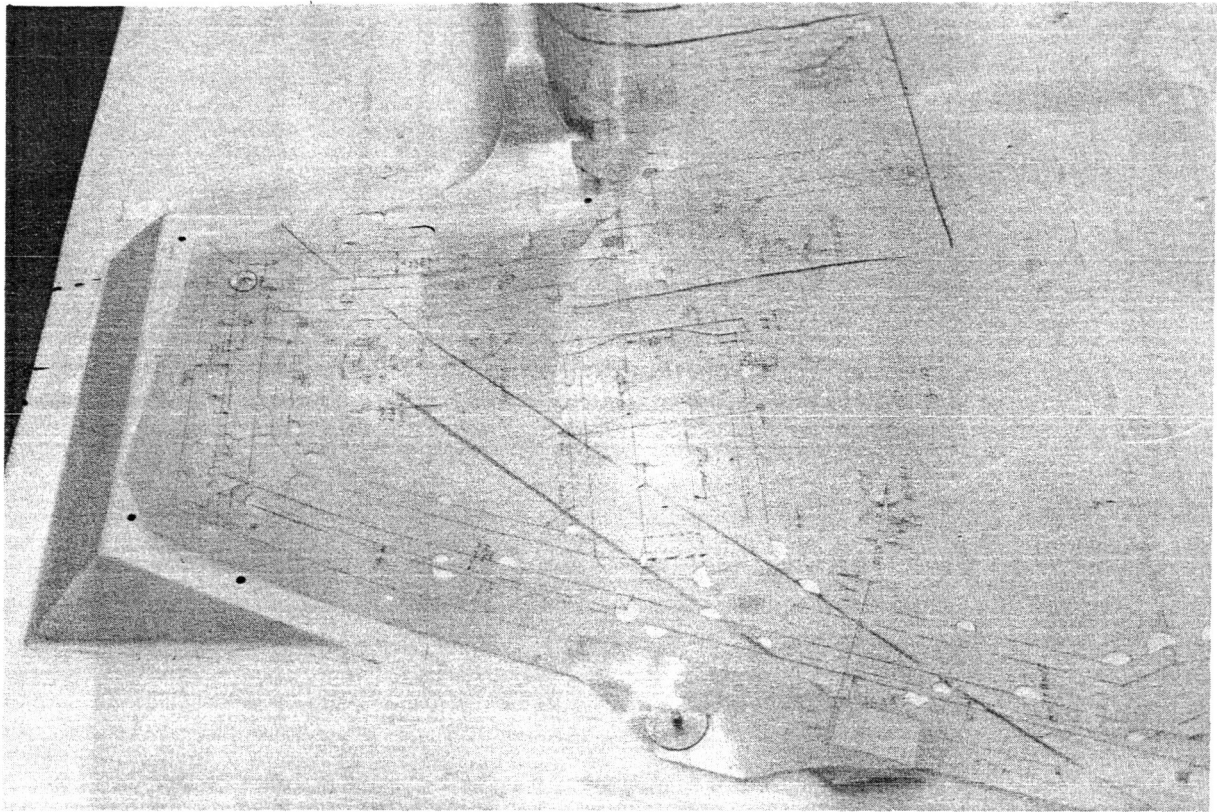
Layup Mandrels—These tools are shown in Figures 227 through 229.

Figure 227. Skin Panel and Layup Mandrel

Figure 228. Skin Panel Layup Tool

Figure 229. Skin Panel Layup Tool Showing Outboard End and Forward Layup Areas

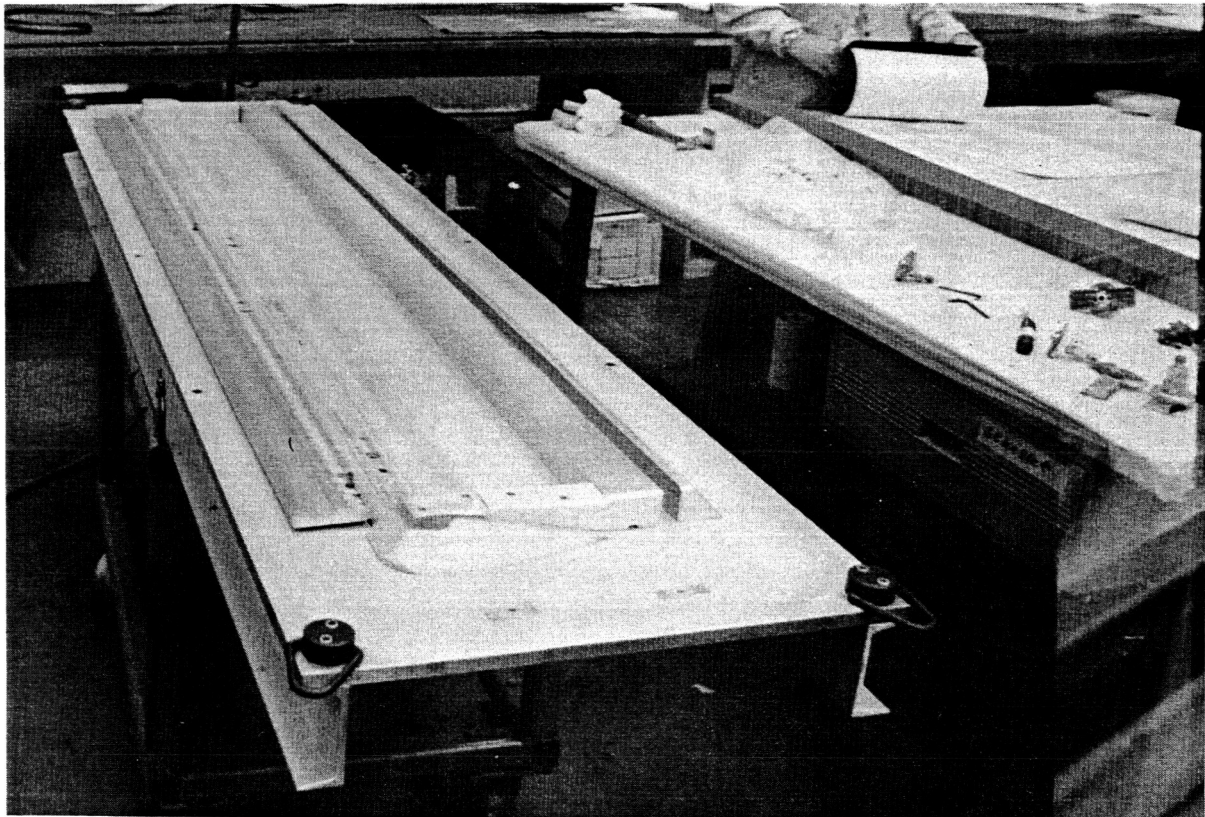
Figure 230. Control Tab Bonding Tool

Bonding Assembly Jig—A tool used for three stages of bonding of spar, core, doublers, and skins (fig. 230).

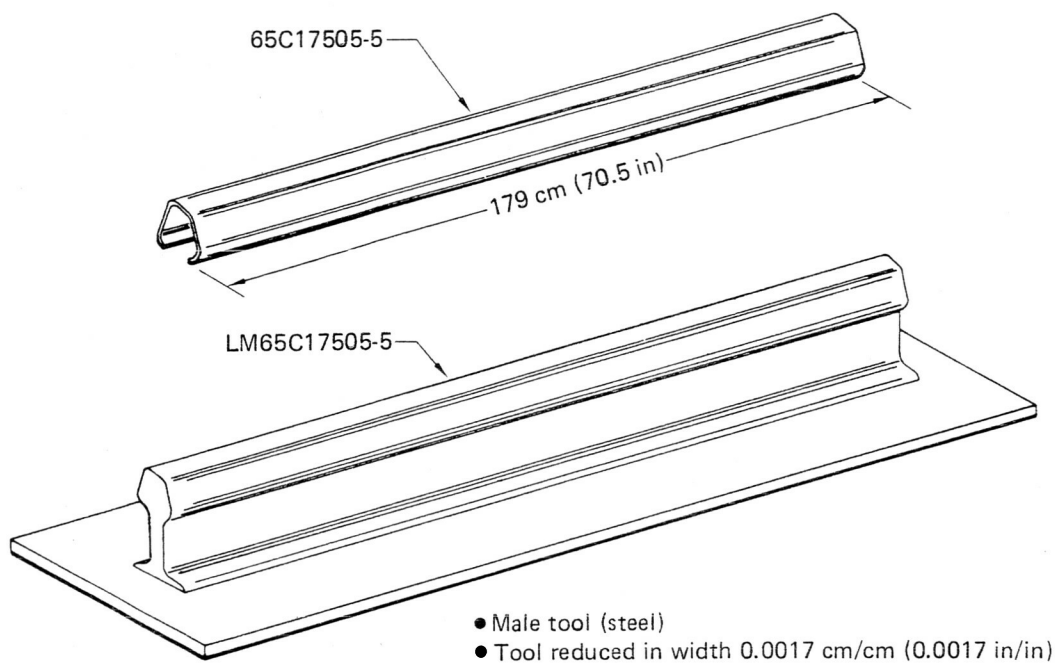
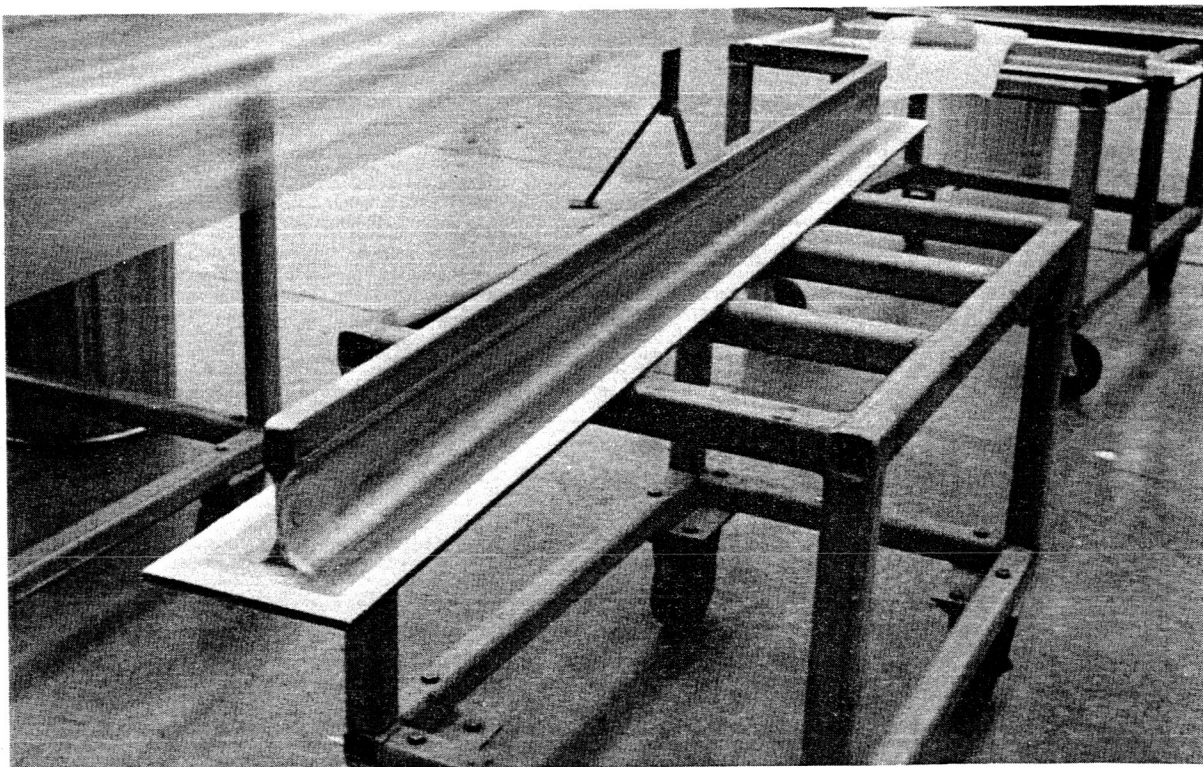
Layup Mandrel—This tool is shown in Figures 231 and 232.

Figure 231. Control Tab Spar

Figure 232. Control Tab Rear-Spar Layup Tool

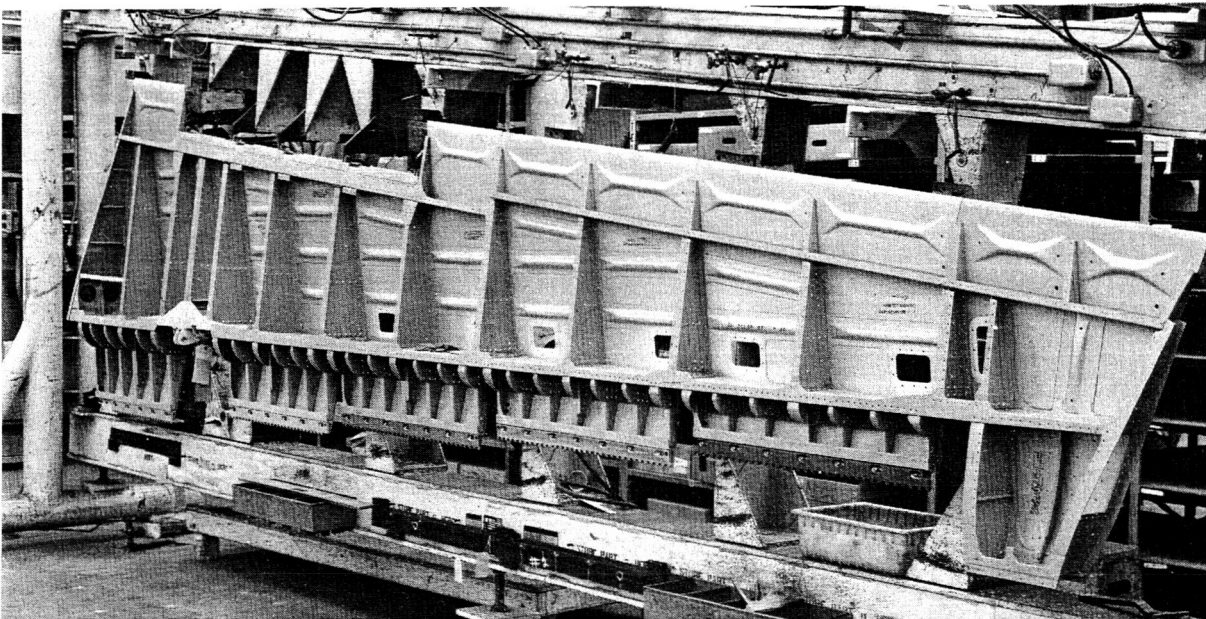
Figure 233. Model 727 Metal Elevator Structure

New tools were designed and fabricated for elevator assembly operations. These tools are similar to existing metal elevator tools, but are fewer in number because the major assembly work is accomplished in one stage versus three stages for the metal elevator. The 727 metal elevator structure is shown in Figure 233. The reduced number of internal structural members and one-piece cover panels for composite units allowed one-stage operation. These features and other engineering design variances disallowed using existing tool designs and constructing dual-purpose tools for elevator production. Tooling consisted of left- and right-hand units for rear spar, front spar/leading edge, and major assembly operations. Figures 234, 235, and 236 display this tooling. Existing master tooling was used as a control medium to ensure interchangeability at the stabilizer/elevator hinge centerline. A new master gage was constructed for control of the tab/elevator hinge line.

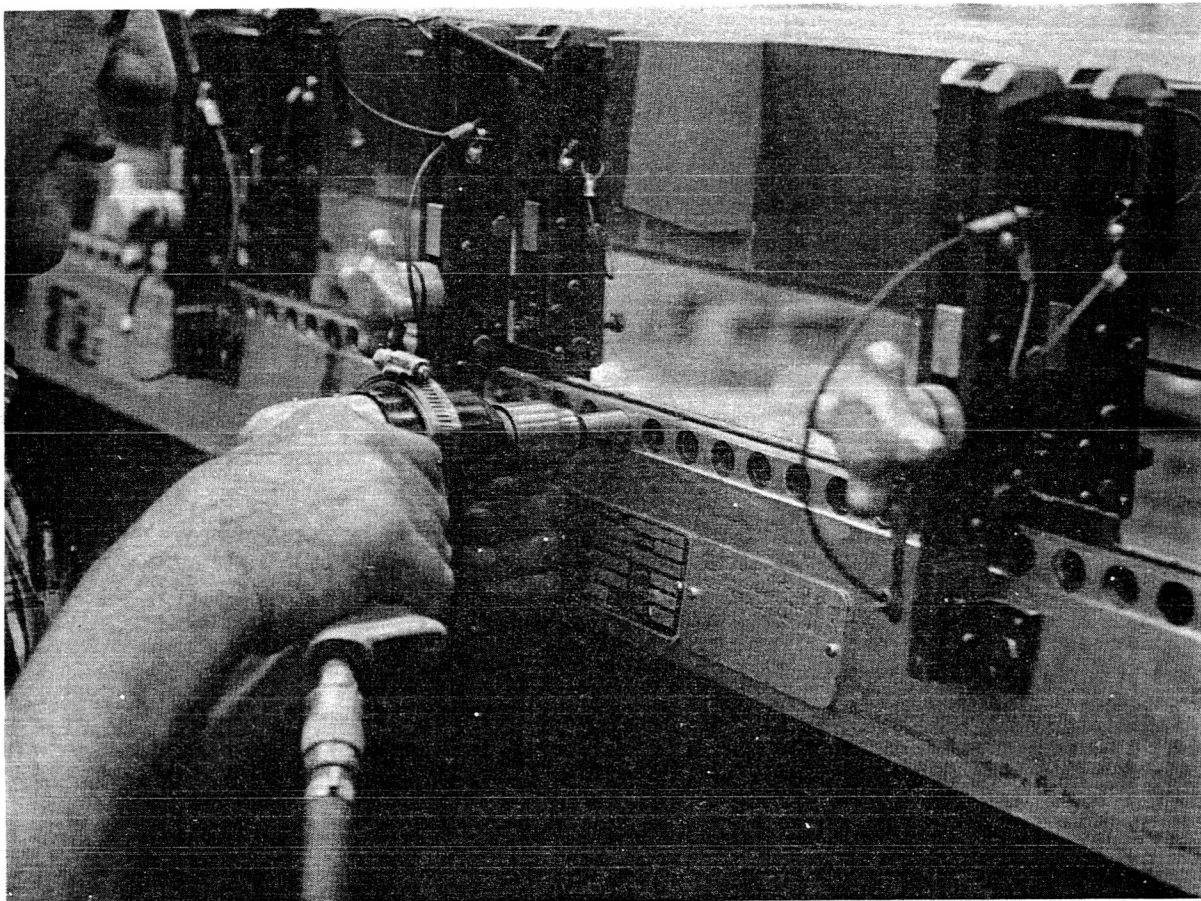
Figure 238. Drilling Operation Using Index Holes Sized to Vacuum Nozzle

Index holes sized to the drill motor vacuum nozzle diameter were used in assembly tool drill plates to provide positive dust management during drilling operations, as well as proper hole location and drill alignment (fig. 238). Restricted access prevented use of this system in some areas of the spars and major assemblies. In these areas, a hand-held vacuum hose was used.

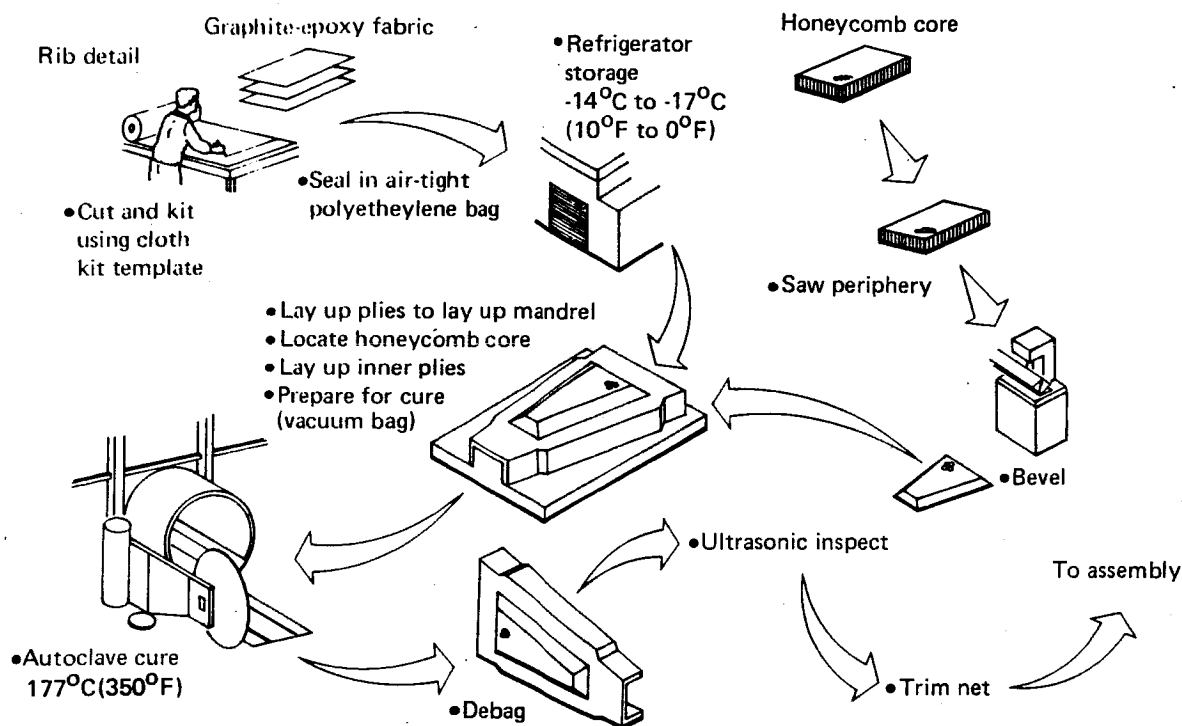
Figure 239. Typical Advanced Composite Fabrication Process

A no-bleed resin system with a 176.5°C (350°F) cure cycle was used to fabricate all composite components. Figure 239 illustrates the typical operational flow for these components. Both laminates and honeycomb structures followed the kitting, layup, cure, inspection, and trim cycles shown.

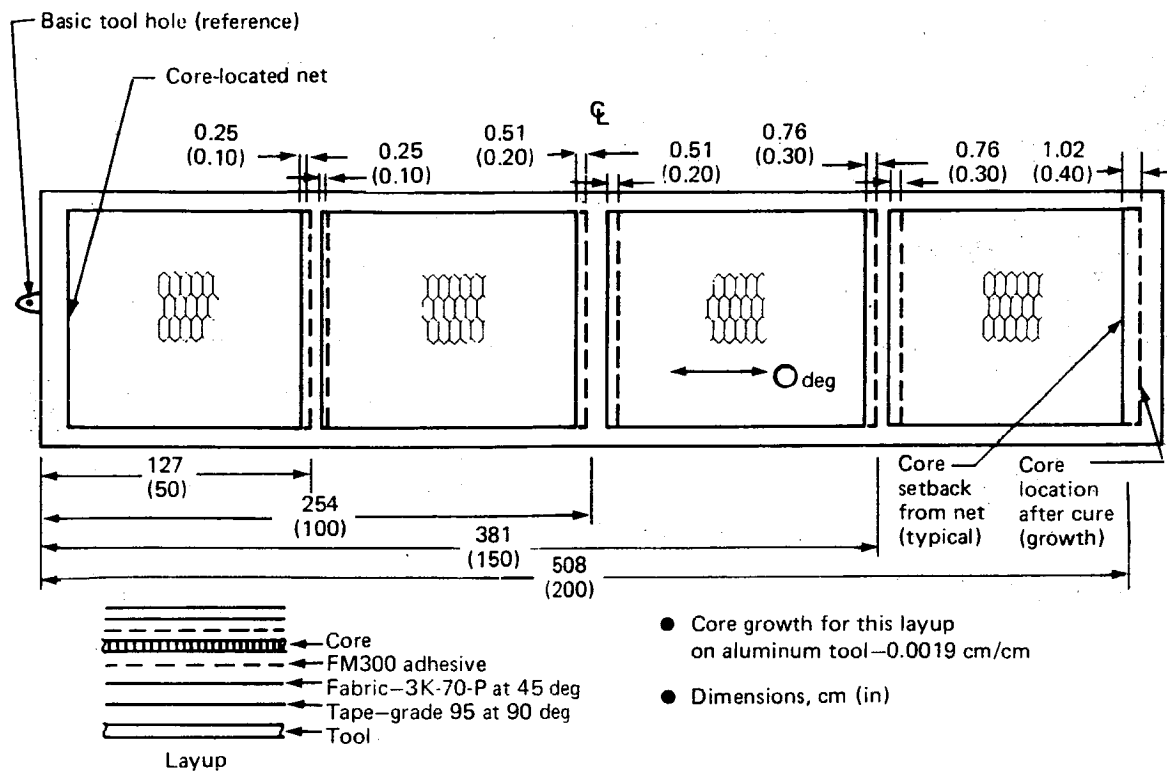
Figure 241. Core Growth Test Panel

rechecked. Results showed an overall length increase of 1.02 cm (0.4 in) or 0.0019 cm/cm (0.0019 in/in) for the core and graphite-epoxy (fig. 241). From these data, core-location templates were reworked to incorporate the growth factor, as displayed in Figure 242. As a result, production units exhibited proper core location after cure. Figures 243 through 252 show the sequence of skin panel fabrication.

Full-size production skin panels have a span of 526 cm (207 in), which caused concern about proper core locations and maintenance of edgeband tolerance during the cure cycle. Since graphite-epoxy cured on the large aluminum tools grows to the point of ~~resin-gel as a function of aluminum expansion~~, it was determined that a growth factor must be incorporated into the layup of core details. This growth factor is shown in Figure 240. To compute the growth factor for the panels, a 61-cm (24-in) wide simulated panel was laid up on the production tool. Four 127-cm (50-in) long core sections were located across the span of the panel, and their location was measured from a reference point on one end. Following the cure cycle, measurements were

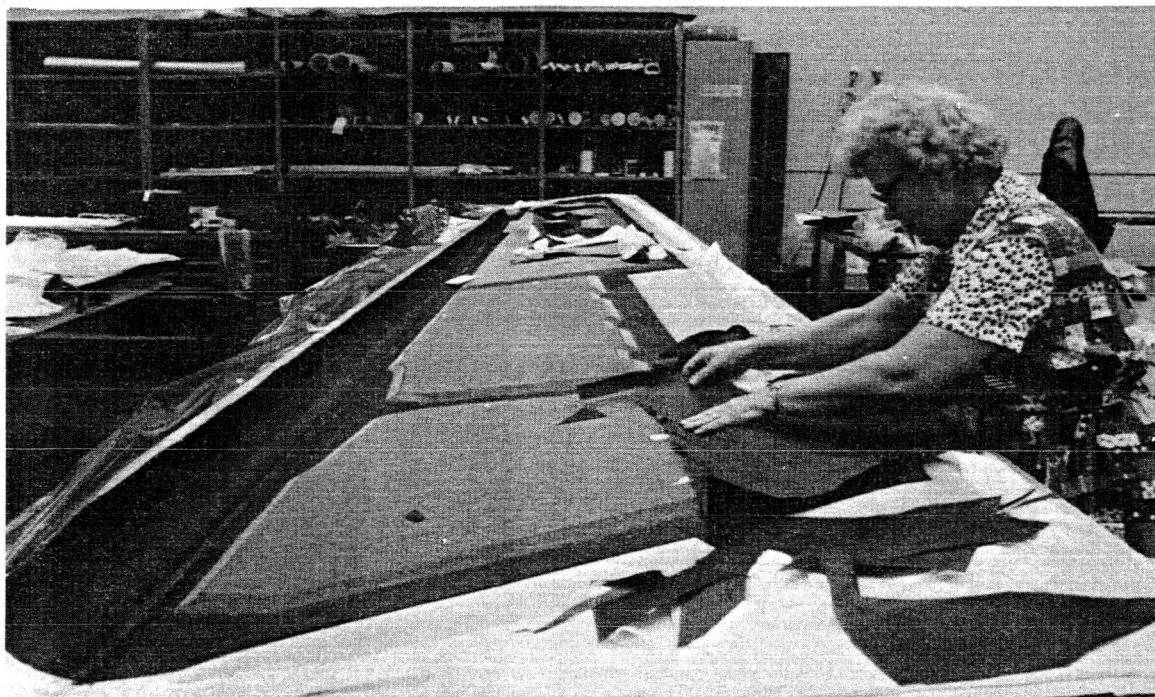
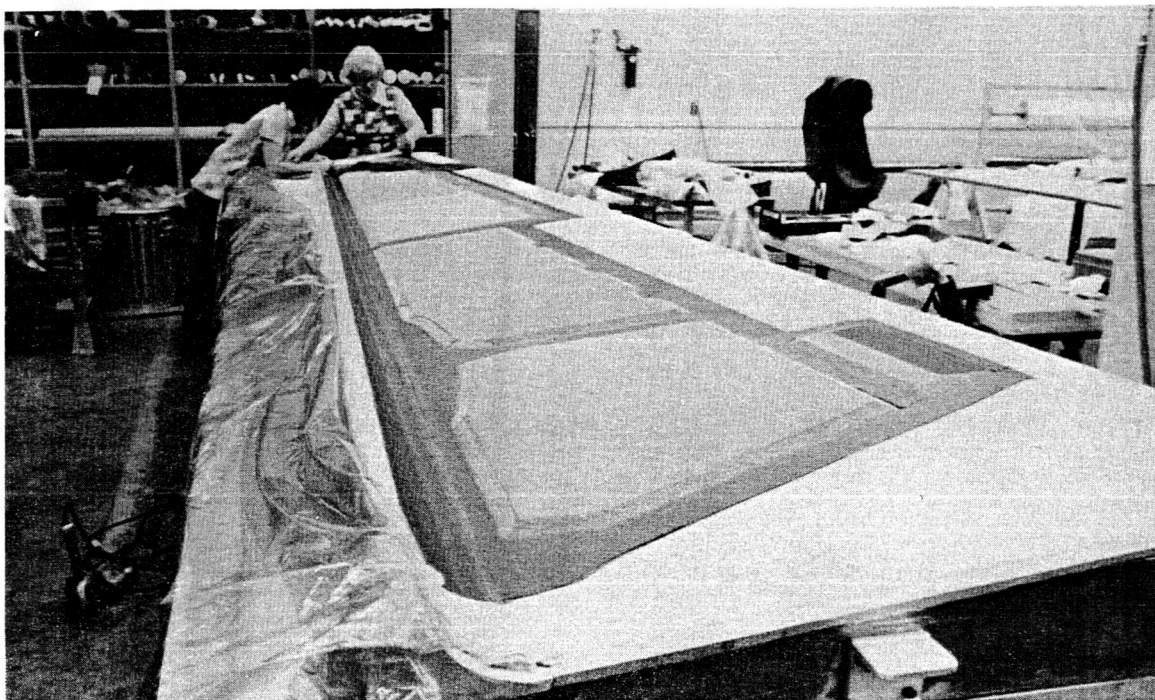
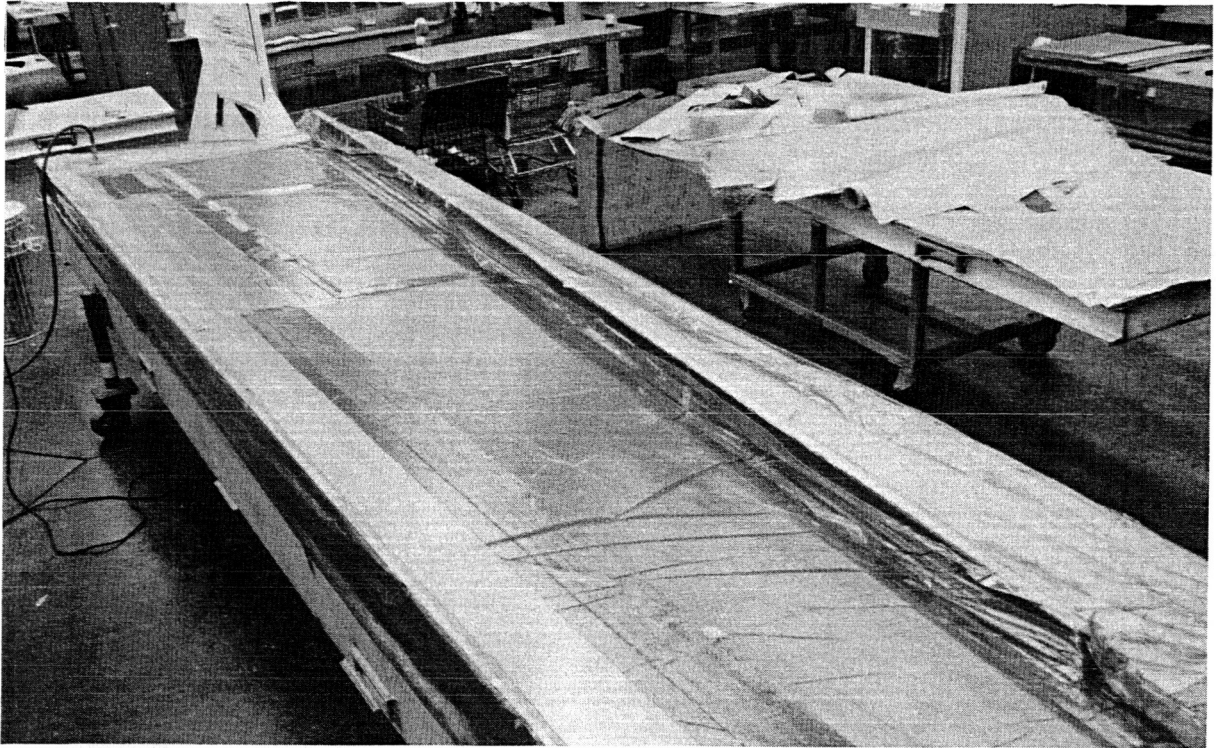
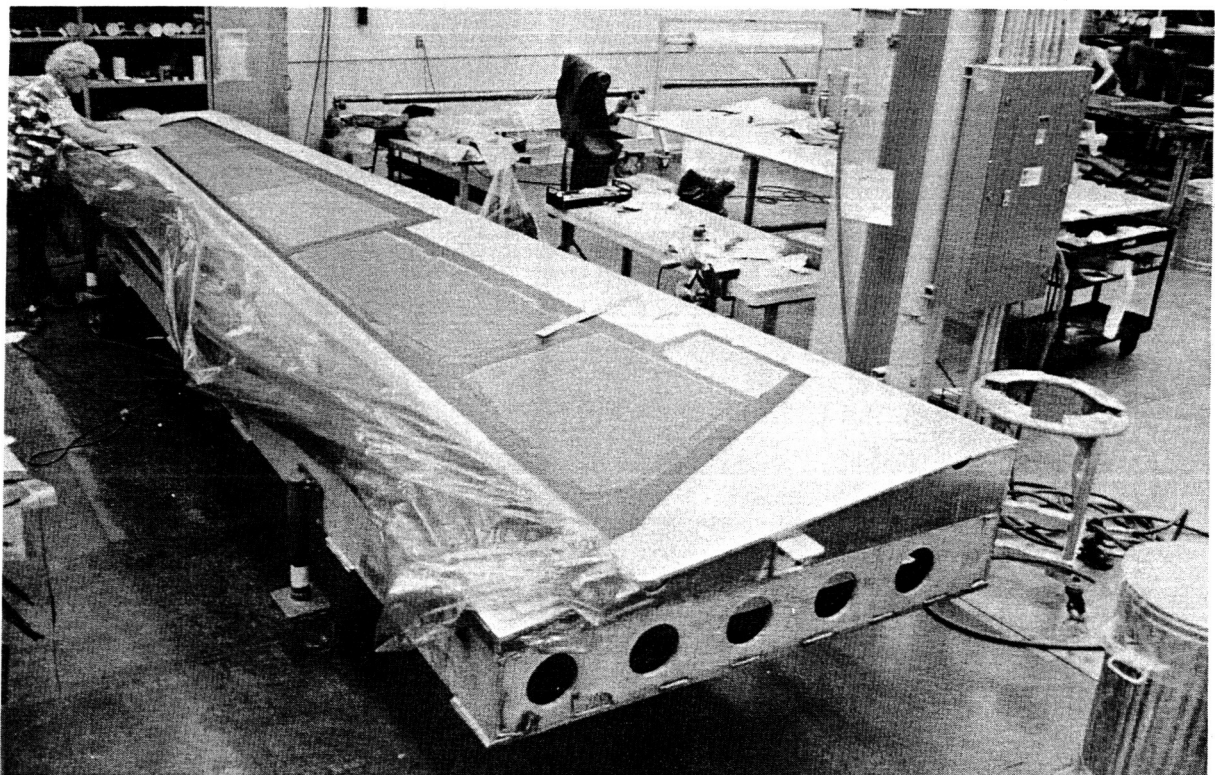
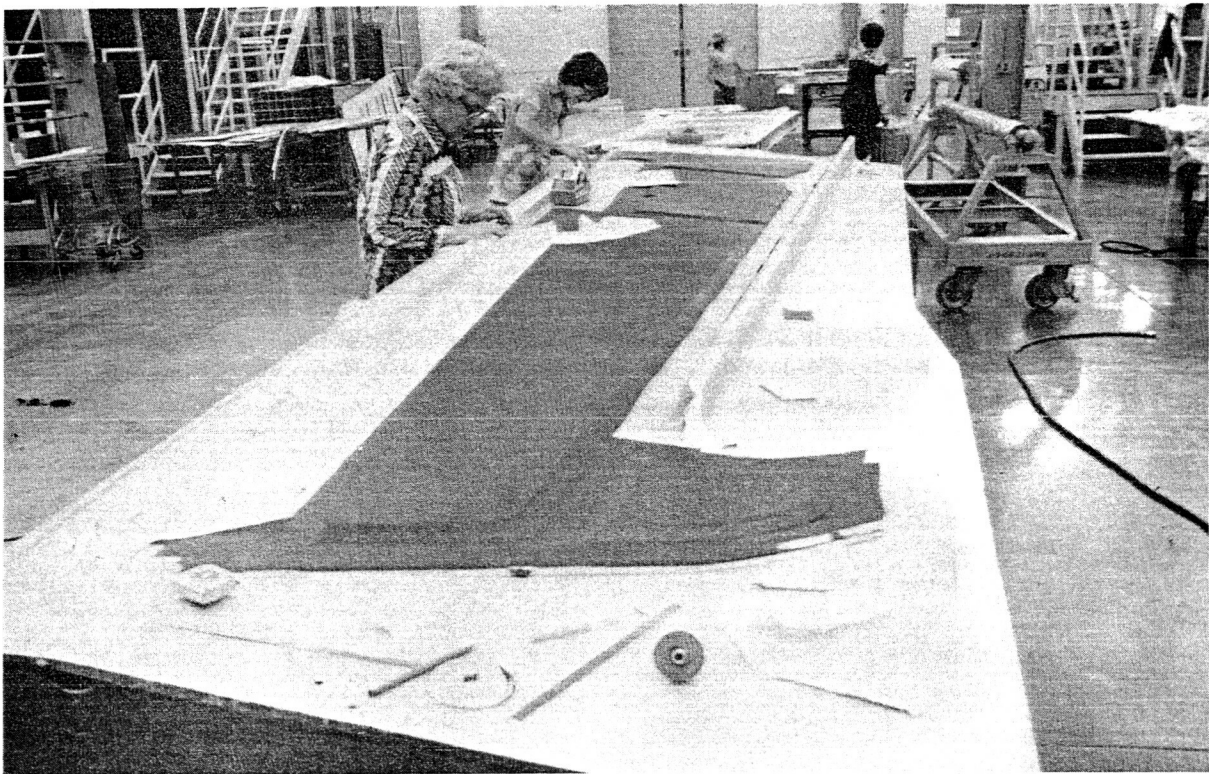
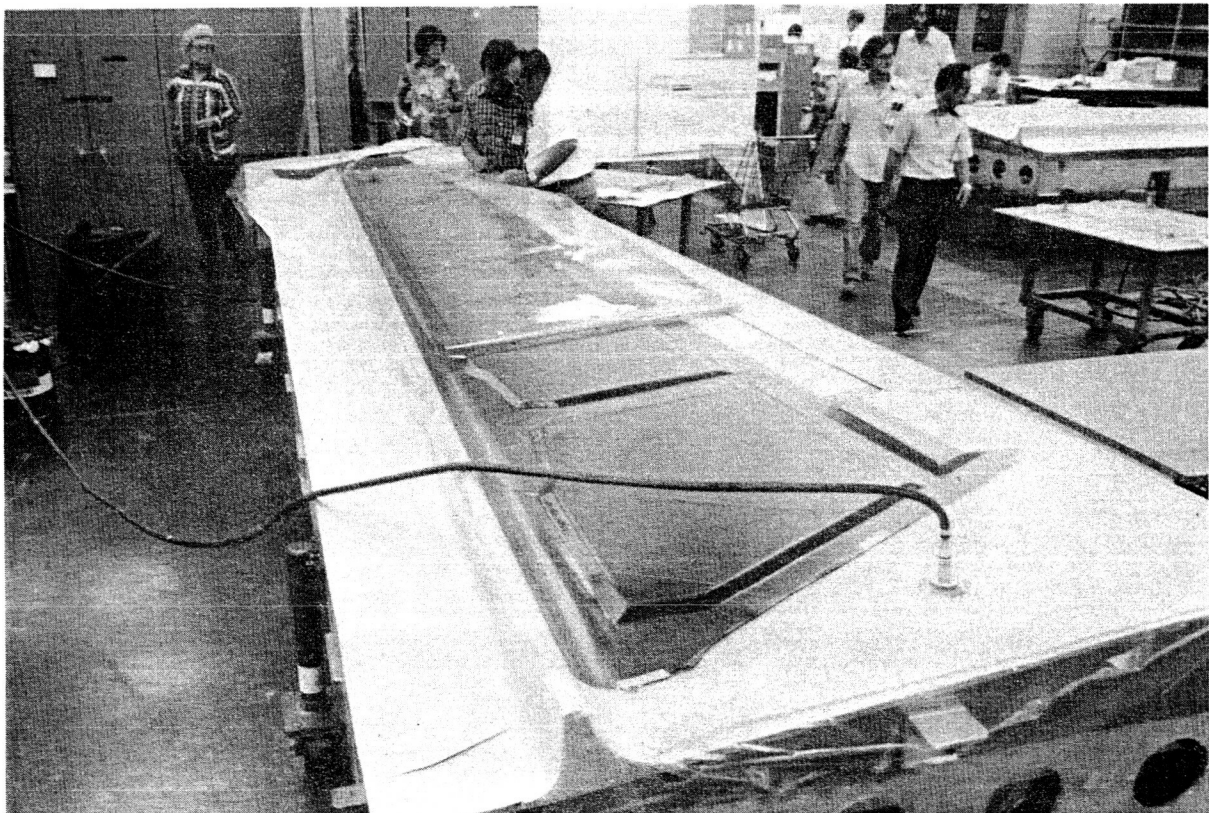
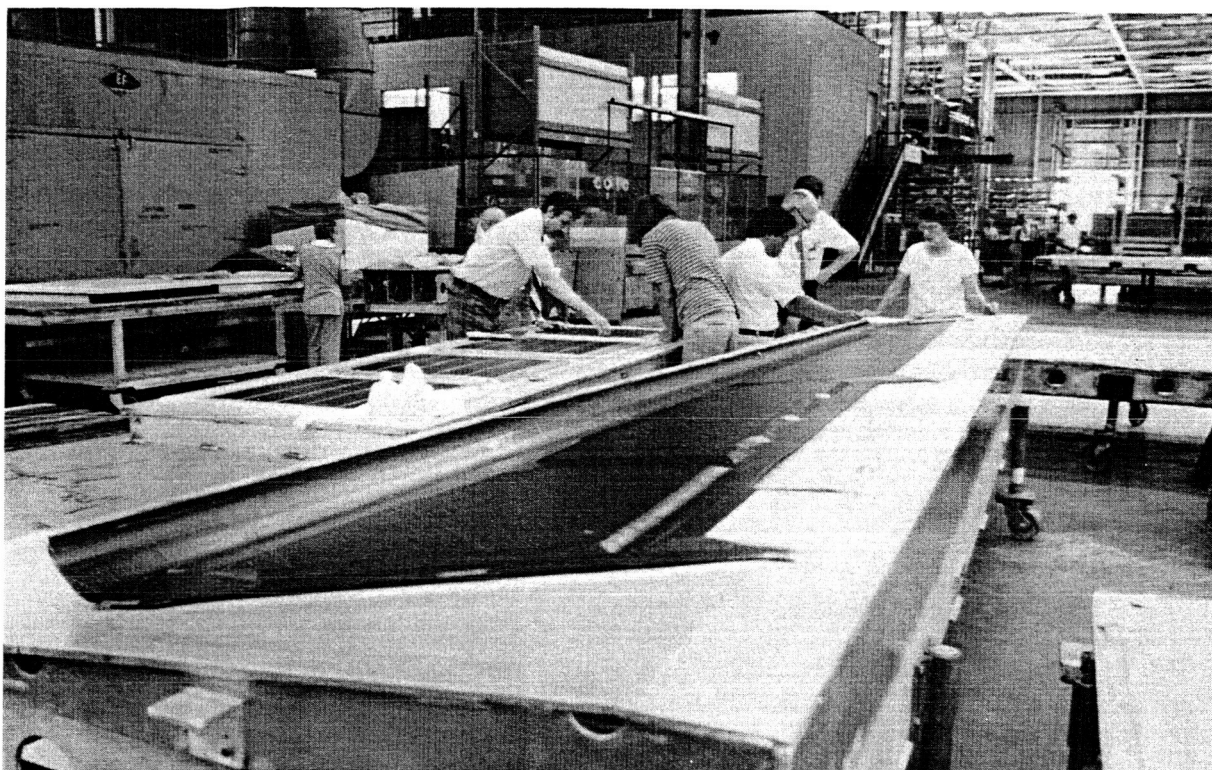
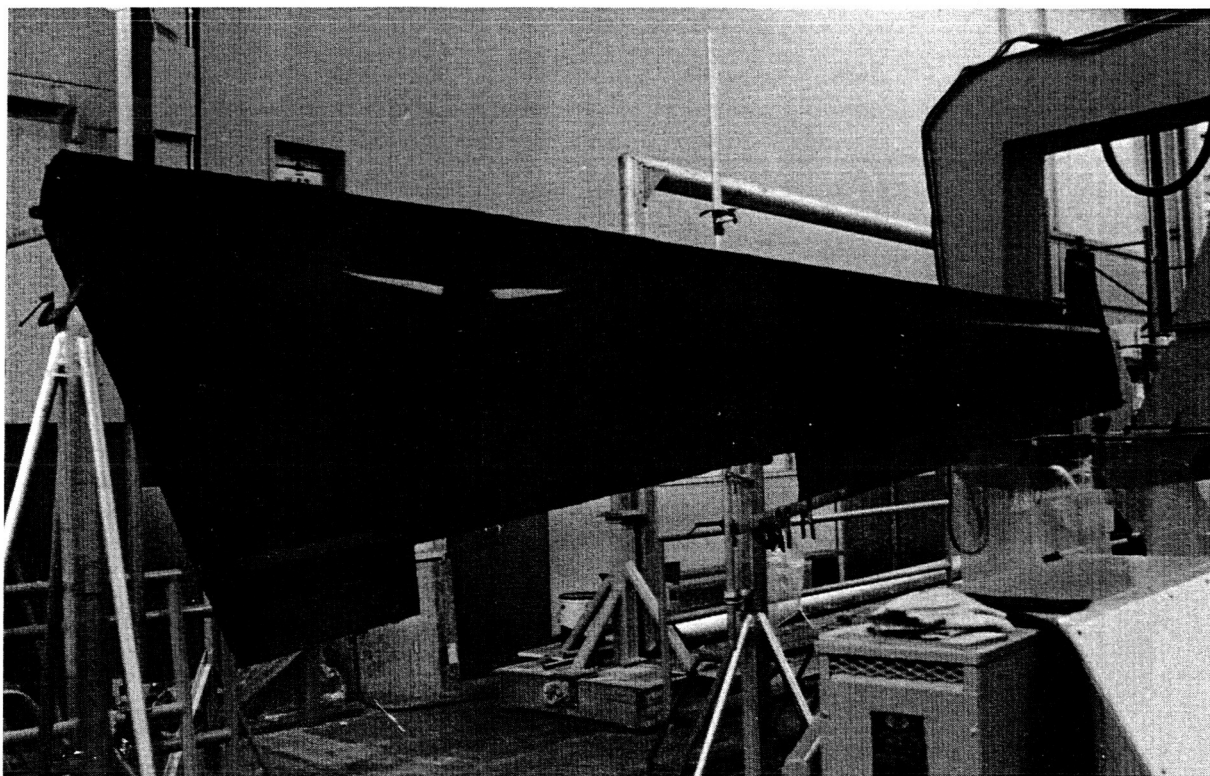
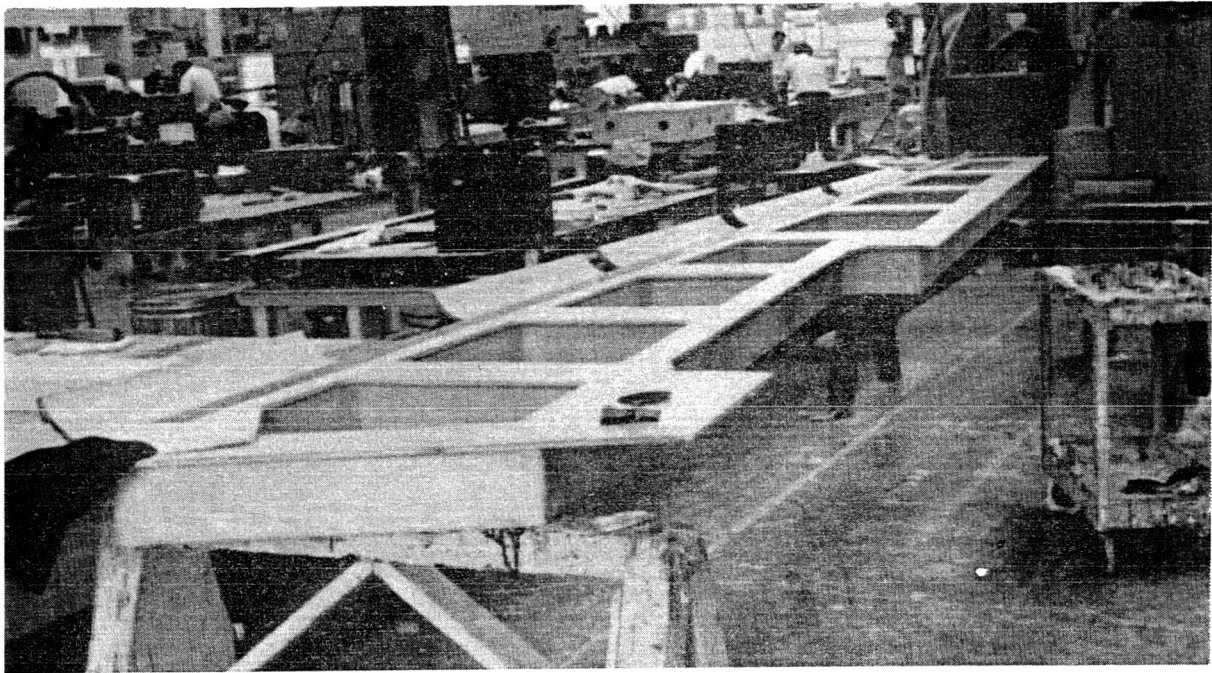
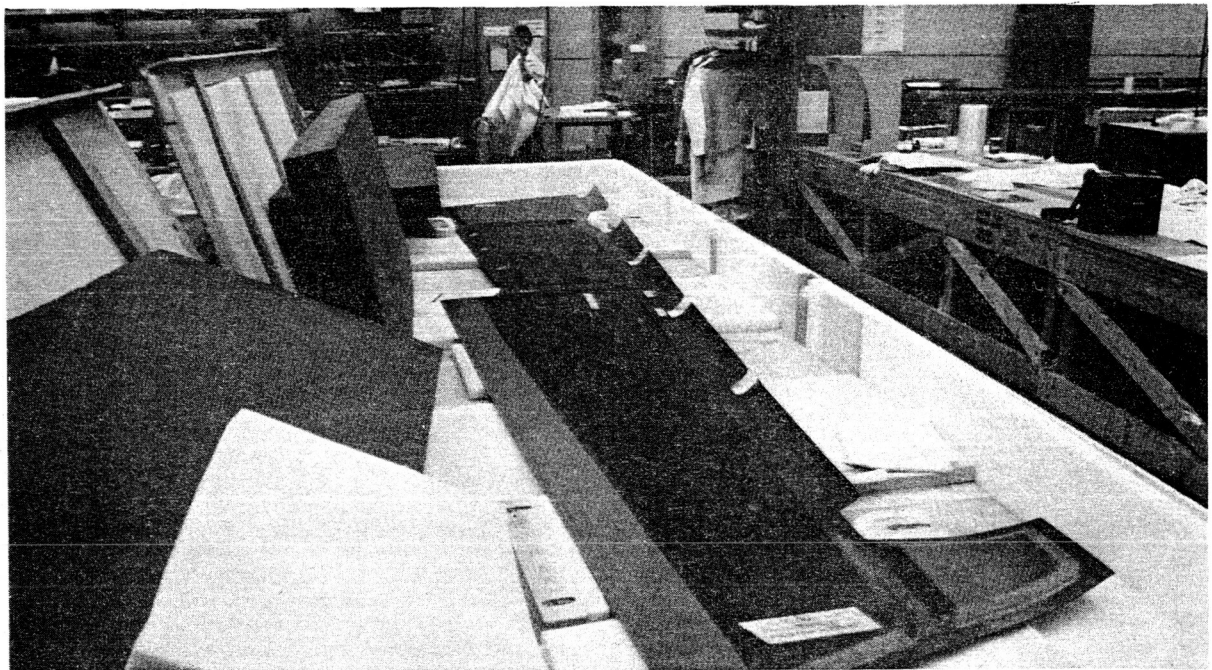
Figure 243. Layup of Skin Panel

Figure 244. Skin Panel with Outer Layup and Honeycomb Core in Place

Figure 245. Skin Panel Compaction with Vacuum

Figure 246. Application of FM 300 Adhesive to Core of Skin Panel

Figure 247. Application of Fiberglass Layer to Trailing Edge of Skin Panel

Figure 248. Upper Skin Panel Ready for Autoclave Cure

Figure 249. Upper Skin Panel After Autoclave Cure

Figure 250. Upper Skin Panel in TTU Inspection

Figure 251. Trim Tool for Upper Skin Panel

Figure 252. Upper Skin Panel Ready for Transport to Assembly Shop

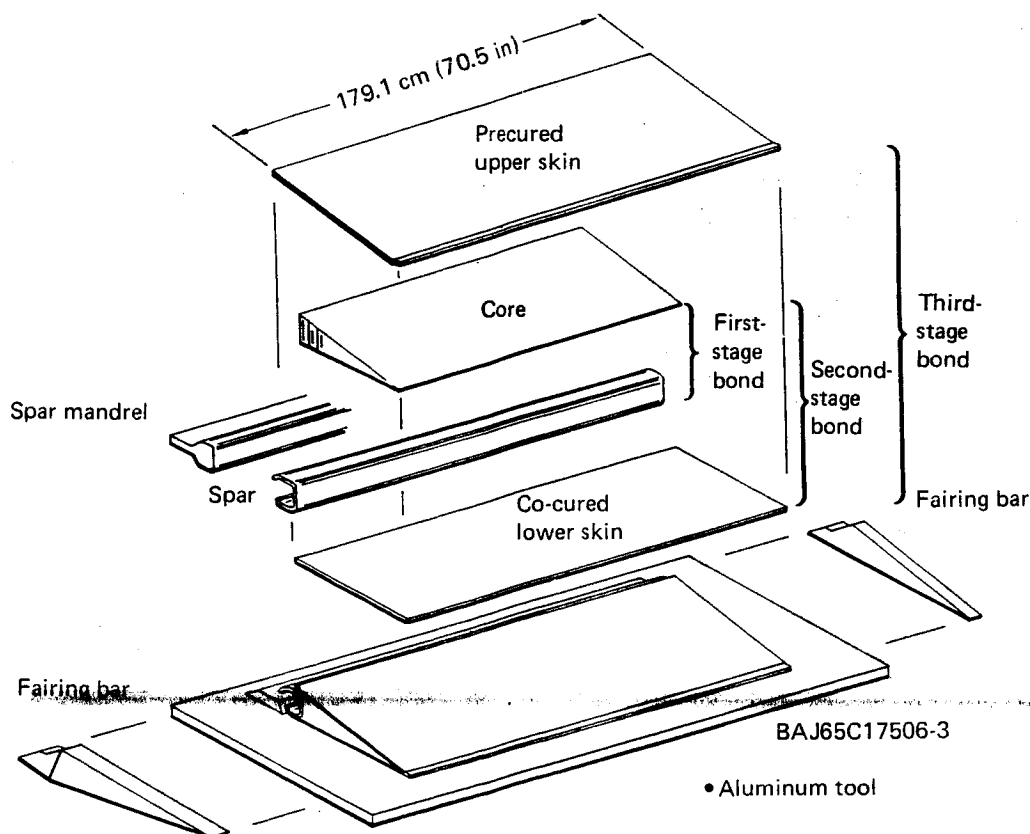
Figure 253. Control Tab Bonding Sequence

The tab is fabricated in three stages of bonding. In the first stage, a block of core is bonded to the precured graphite-epoxy spar. The tool-side skin and trailing-edge fillers then are laid up and bonded to the core and spar. The final stage, after the core and fillers are milled to proper taper, consists of laying up and bonding the opposite, or bag-side, skin. This stage is shown in Figure 253.

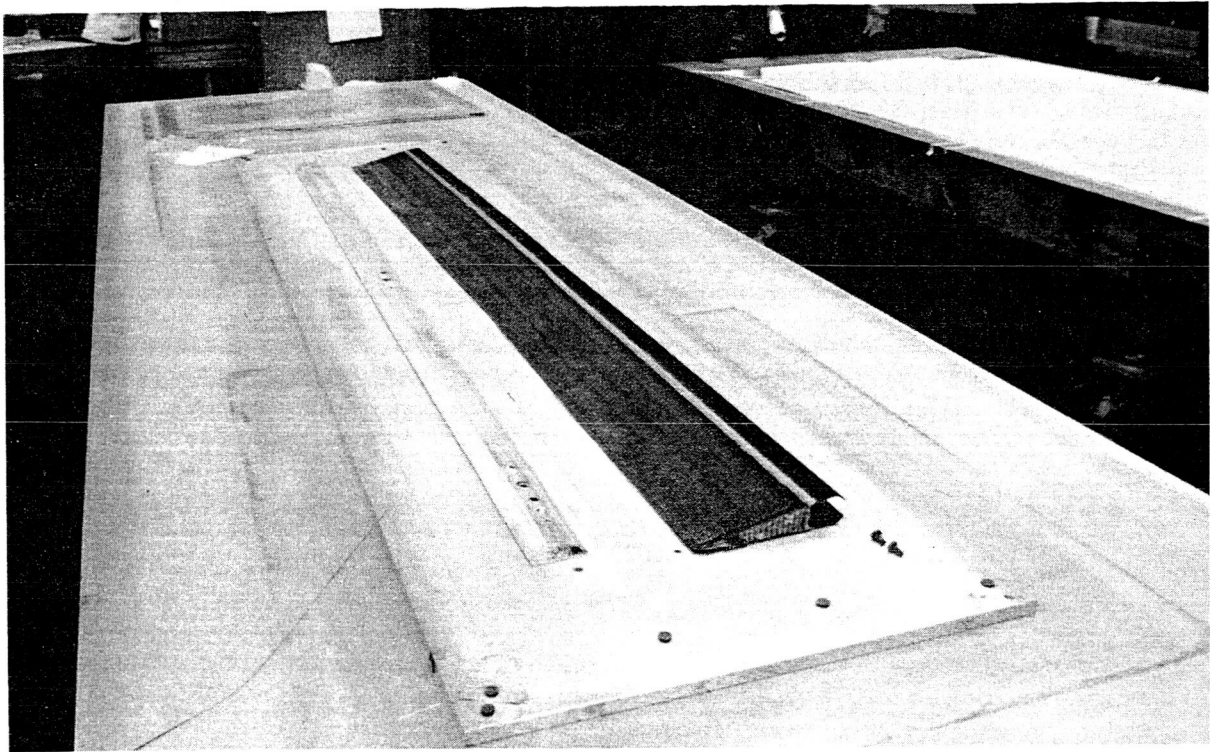
Figure 254. Control Tab Second Stage Bond Showing Spar, Core, Toolside Skin, and Trailing-Edge Fillers

A detailed analysis of each of the bonding operations and the engineering design indicated two areas of potential reasons for the warpage. One was an unbalanced layup between the tool-side skin and the cocured trailing-edge filler plies. A change in filler layup from nine plies $+45$ -deg fabric to nine plies alternating $0/45$ -deg fabric was instituted to correct this condition. The other suspect area was cocuring of the bag-side skin. Changing this skin to a precured component for final-stage bonding, coupled with the filler layup change, reduced tab warpage to within acceptable limits (see fig. 254).
